AIR CITY GARAGE
27 S. JEFFERSON STREET
DAYTON, OH 45402

PREPARED BY :
STRUCTURAL ENGINEER

SMA JOB NUMBER : 24.200.020 (ORIGINAL 19.200.154)

AIR CITY GARAGE
UPDATED STRUCTURAL CONDITION STUDY
Dayton, Ohio
March 27, 2024

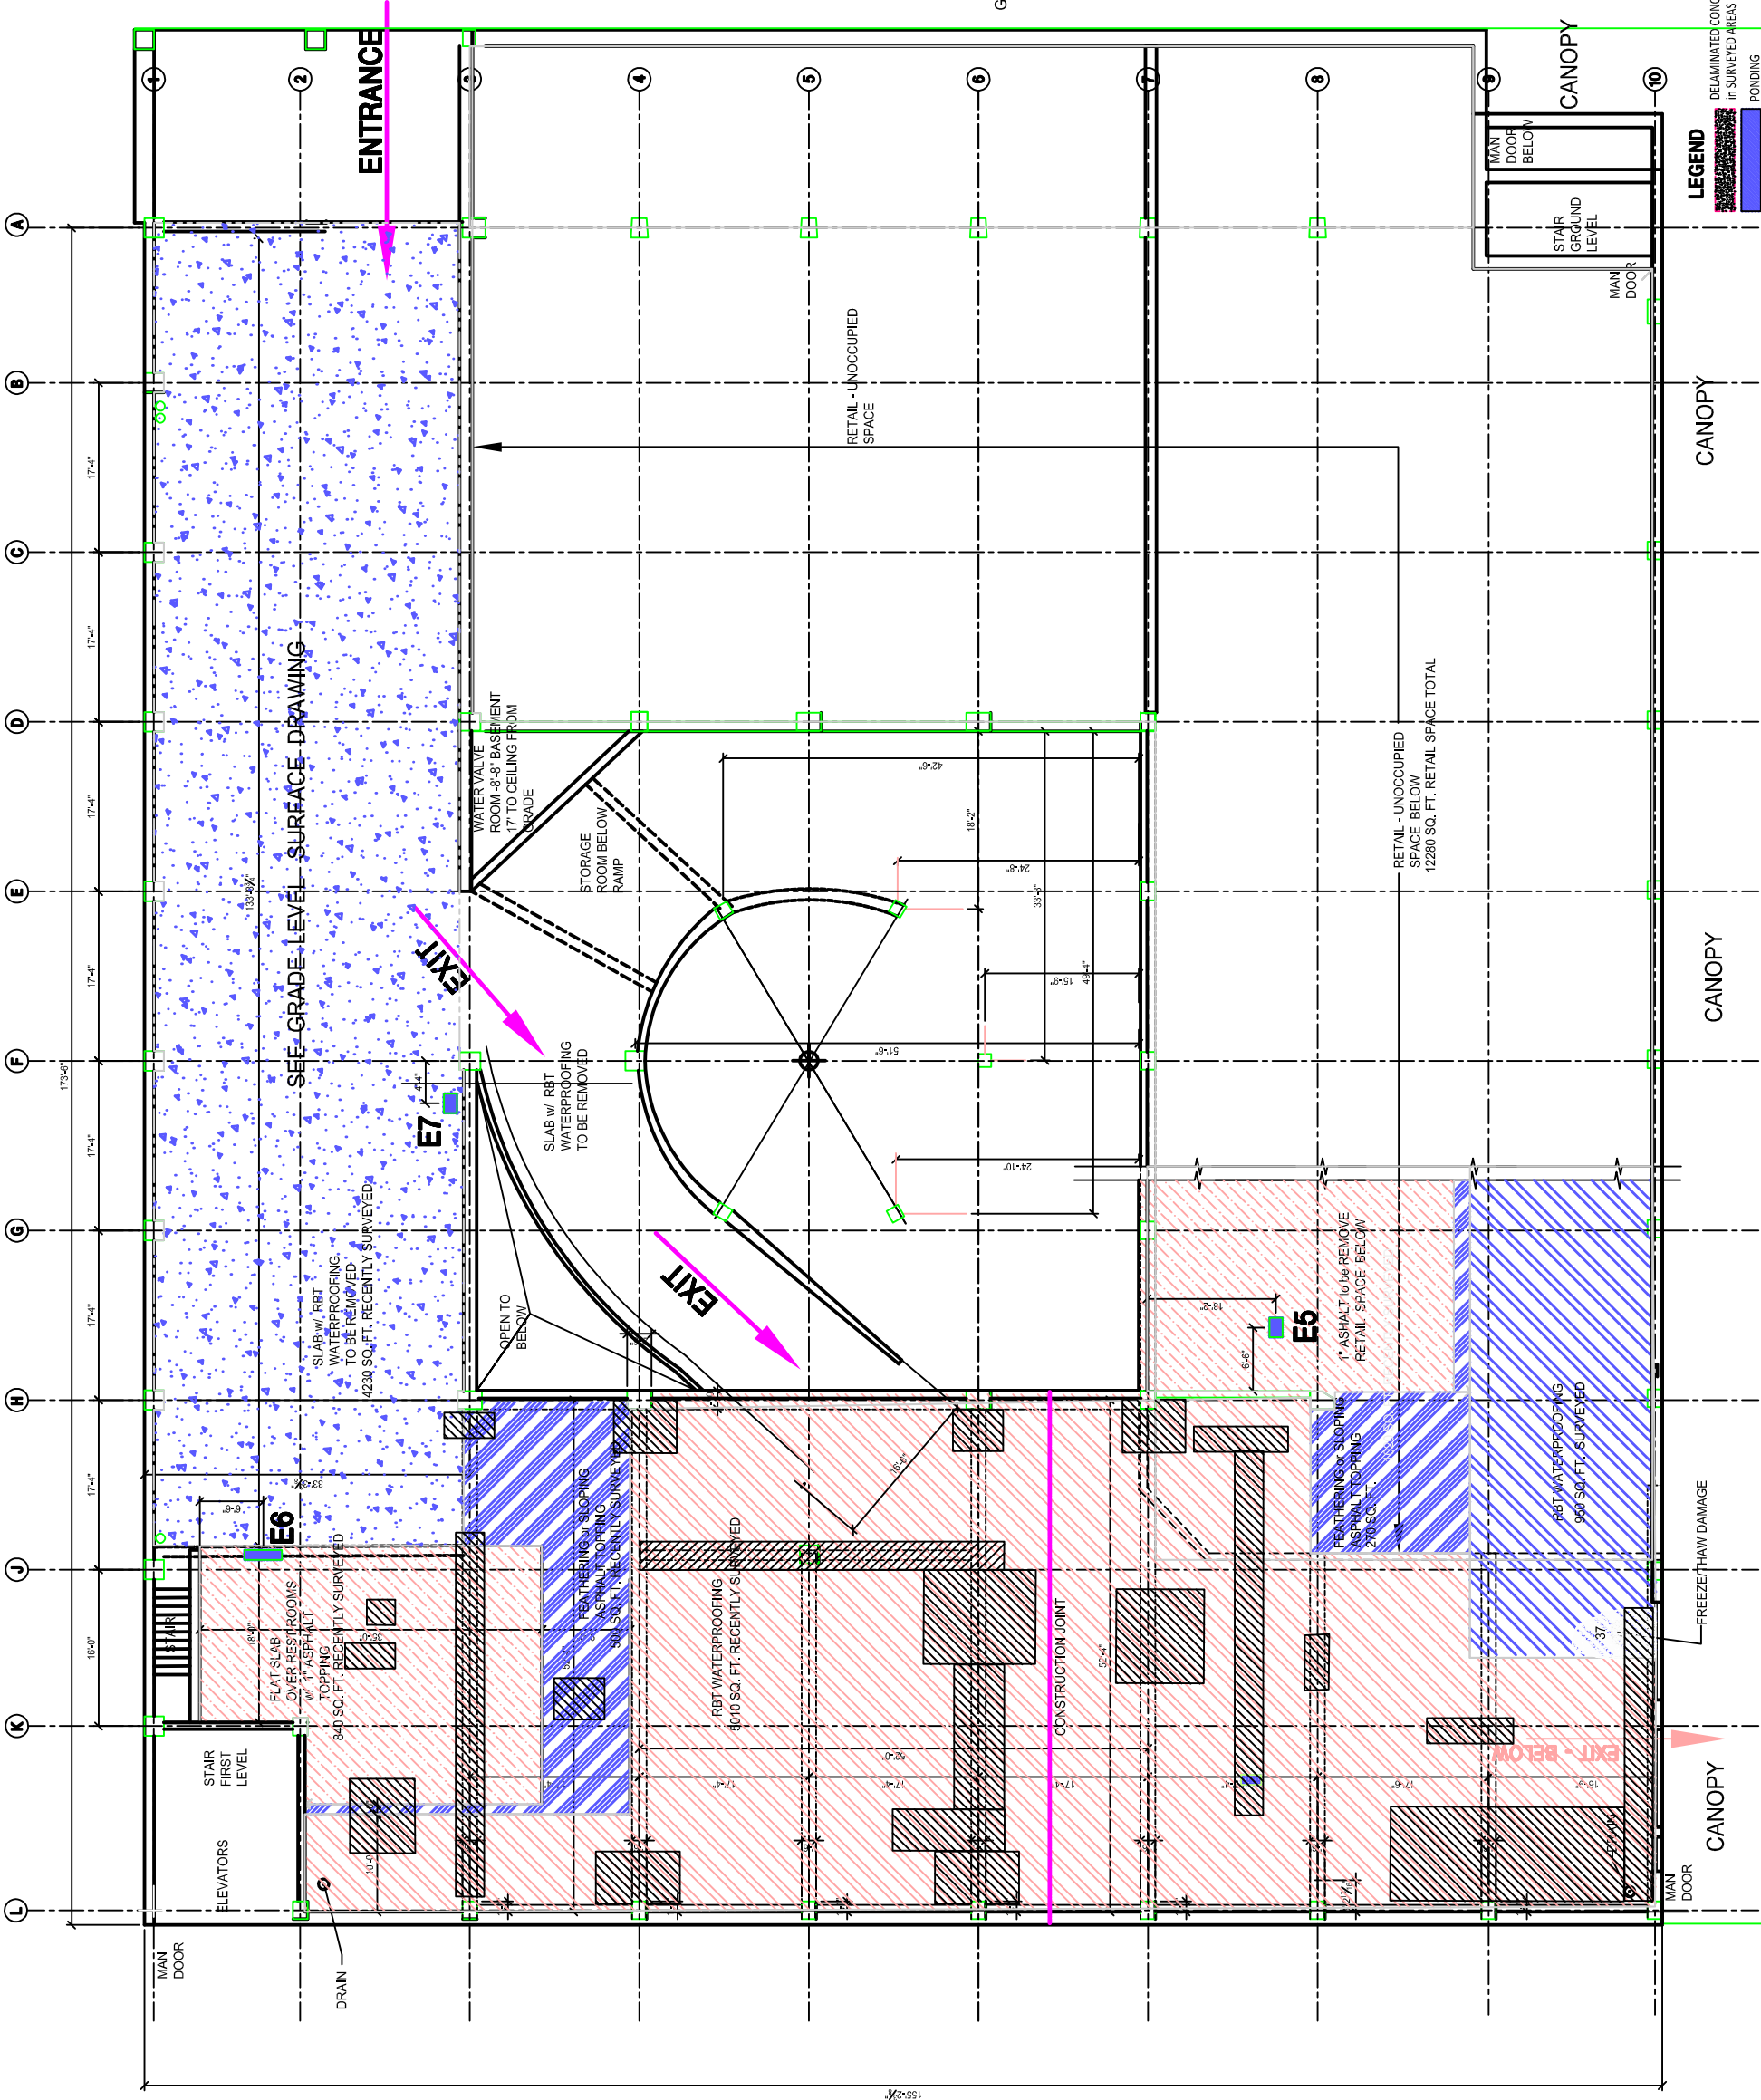
GRADE LEVEL to FIRST LEVEL SURFACE
ESTIMATES TAKEN JUNE 2020
950 SQ. FT. ORIGINAL SURVEYED
4 FREEZE - THAW CONCRETE
107 DELAMINATED CONCRETE
AREA 23,020 SQ. FT.

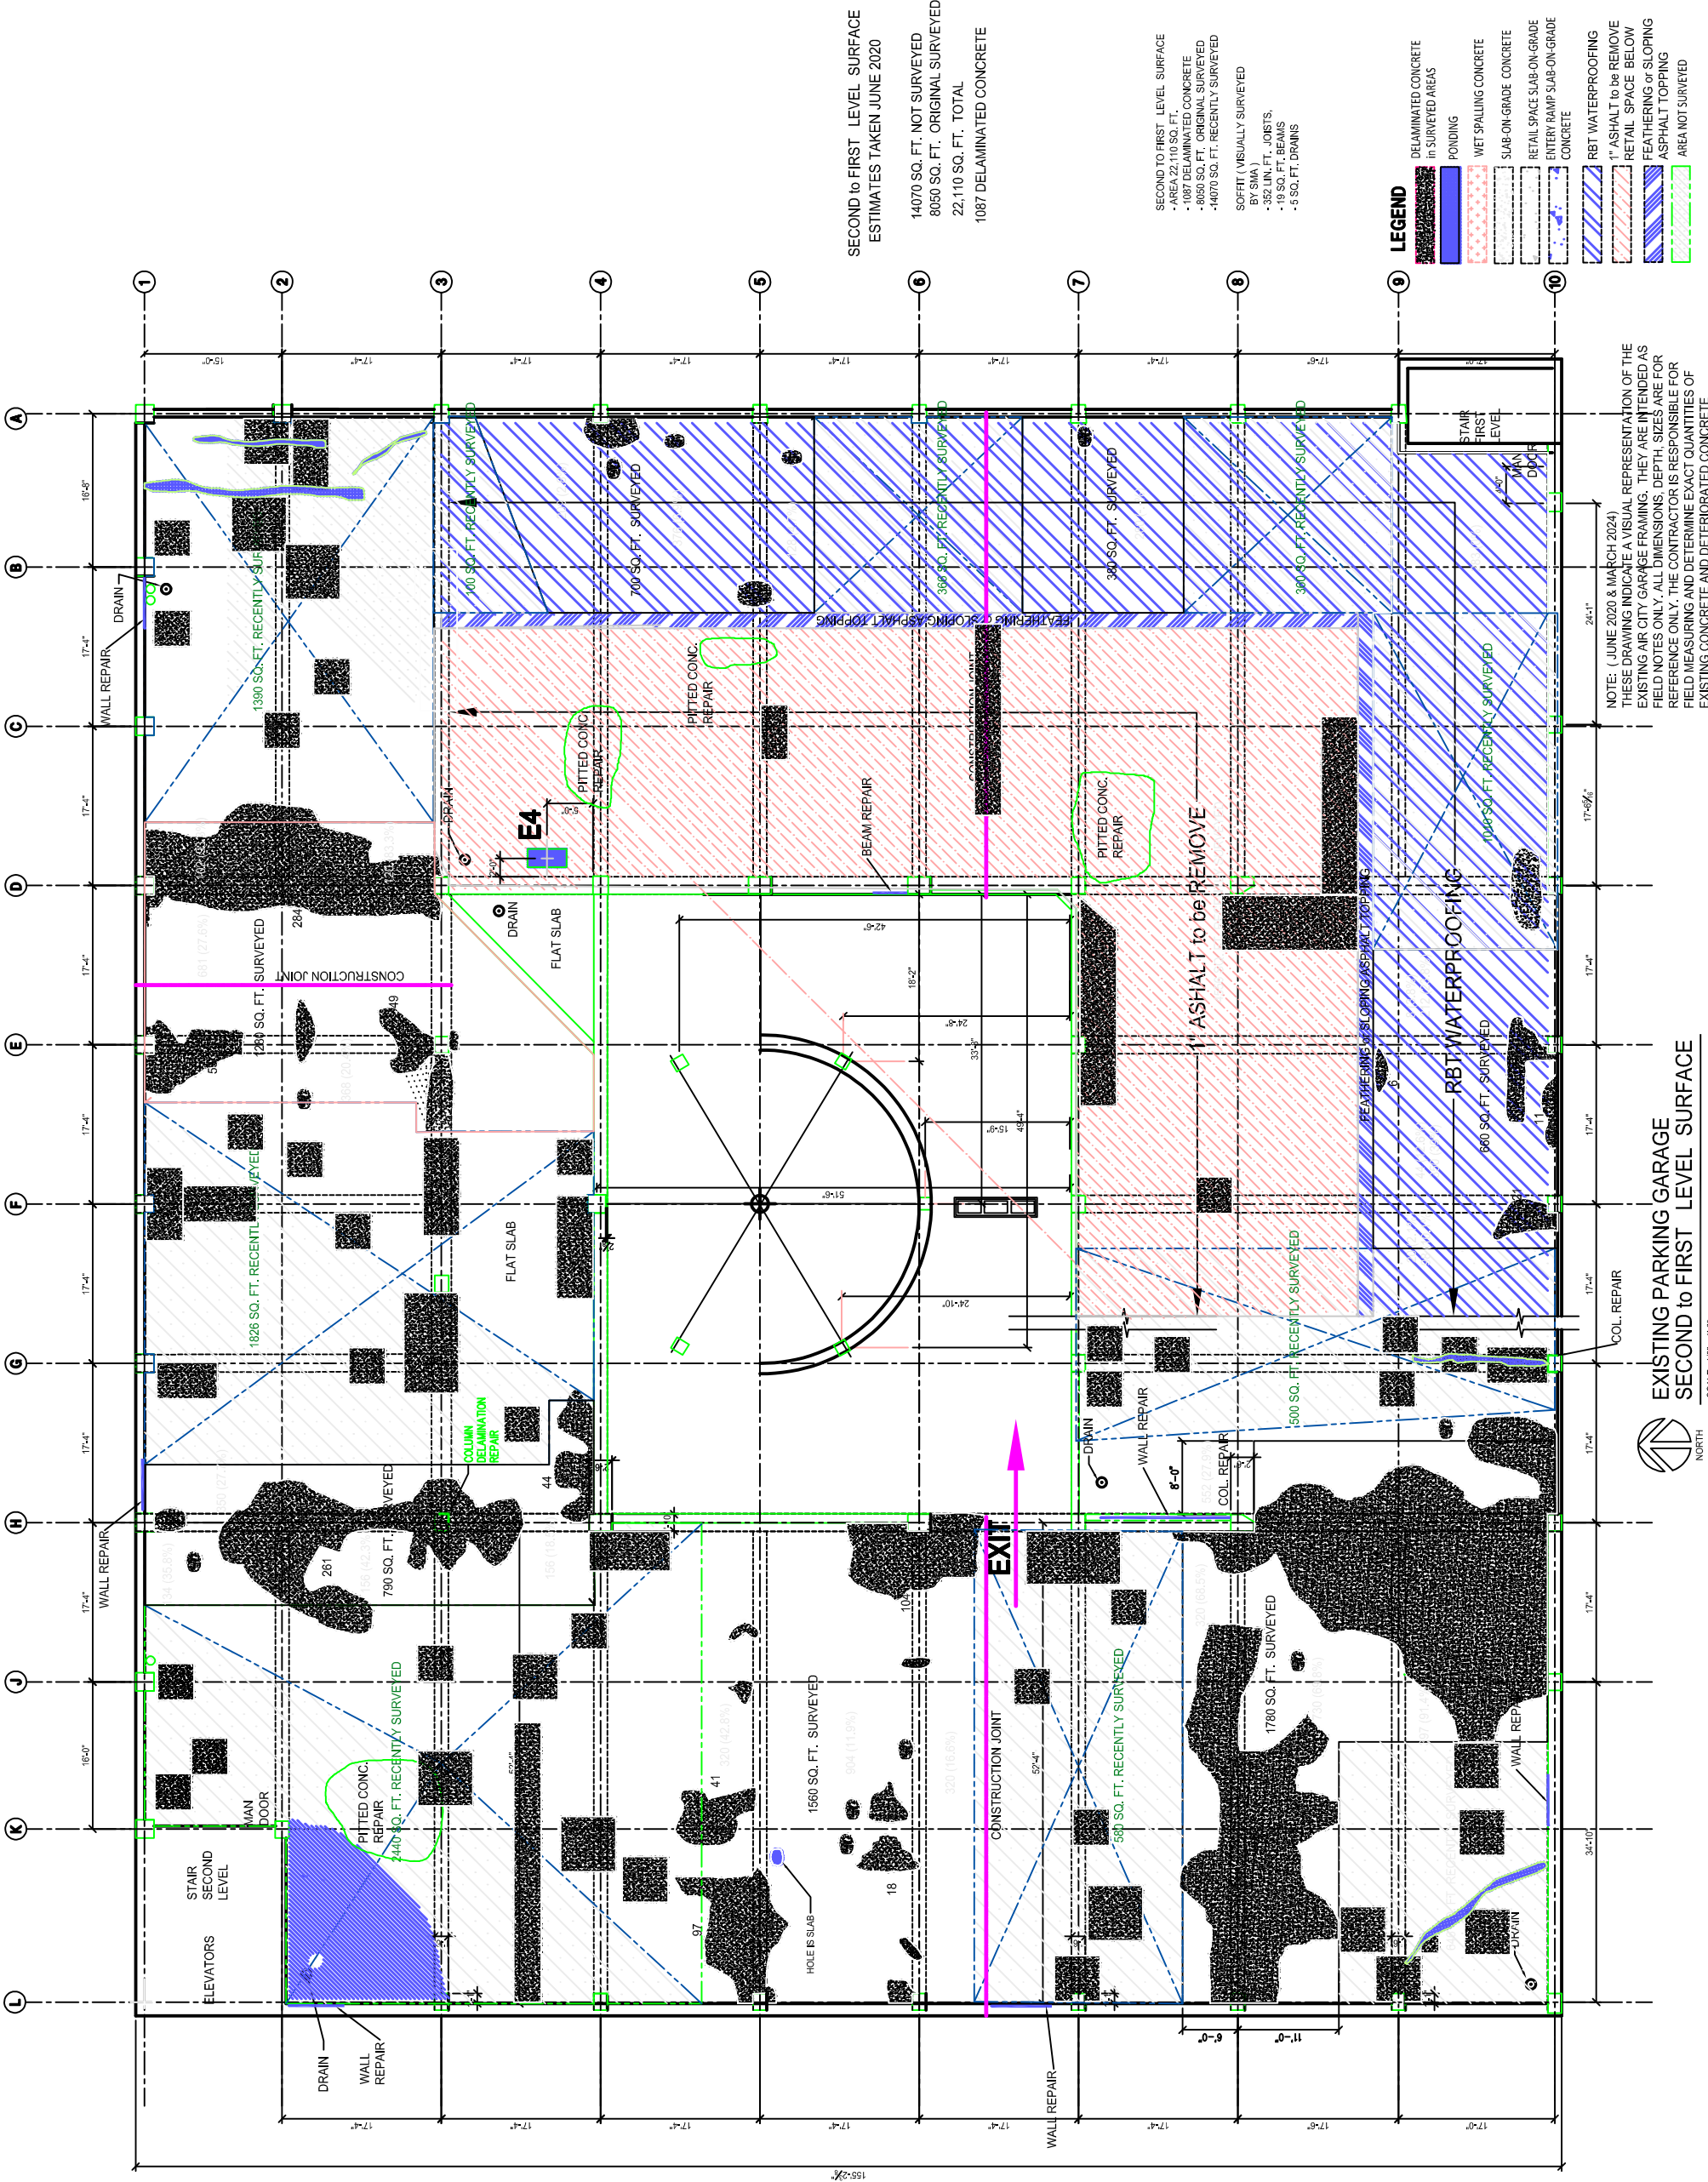
SECOND TO FIRST LEVEL SURFACE
ESTIMATES TAKEN JUNE 2020

14070 SQ. FT. NOT SURVEYED
8050 SQ. FT. ORIGINAL SURVEYED
22,110 SQ. FT. TOTAL
1087 DELAMINATED CONCRETE

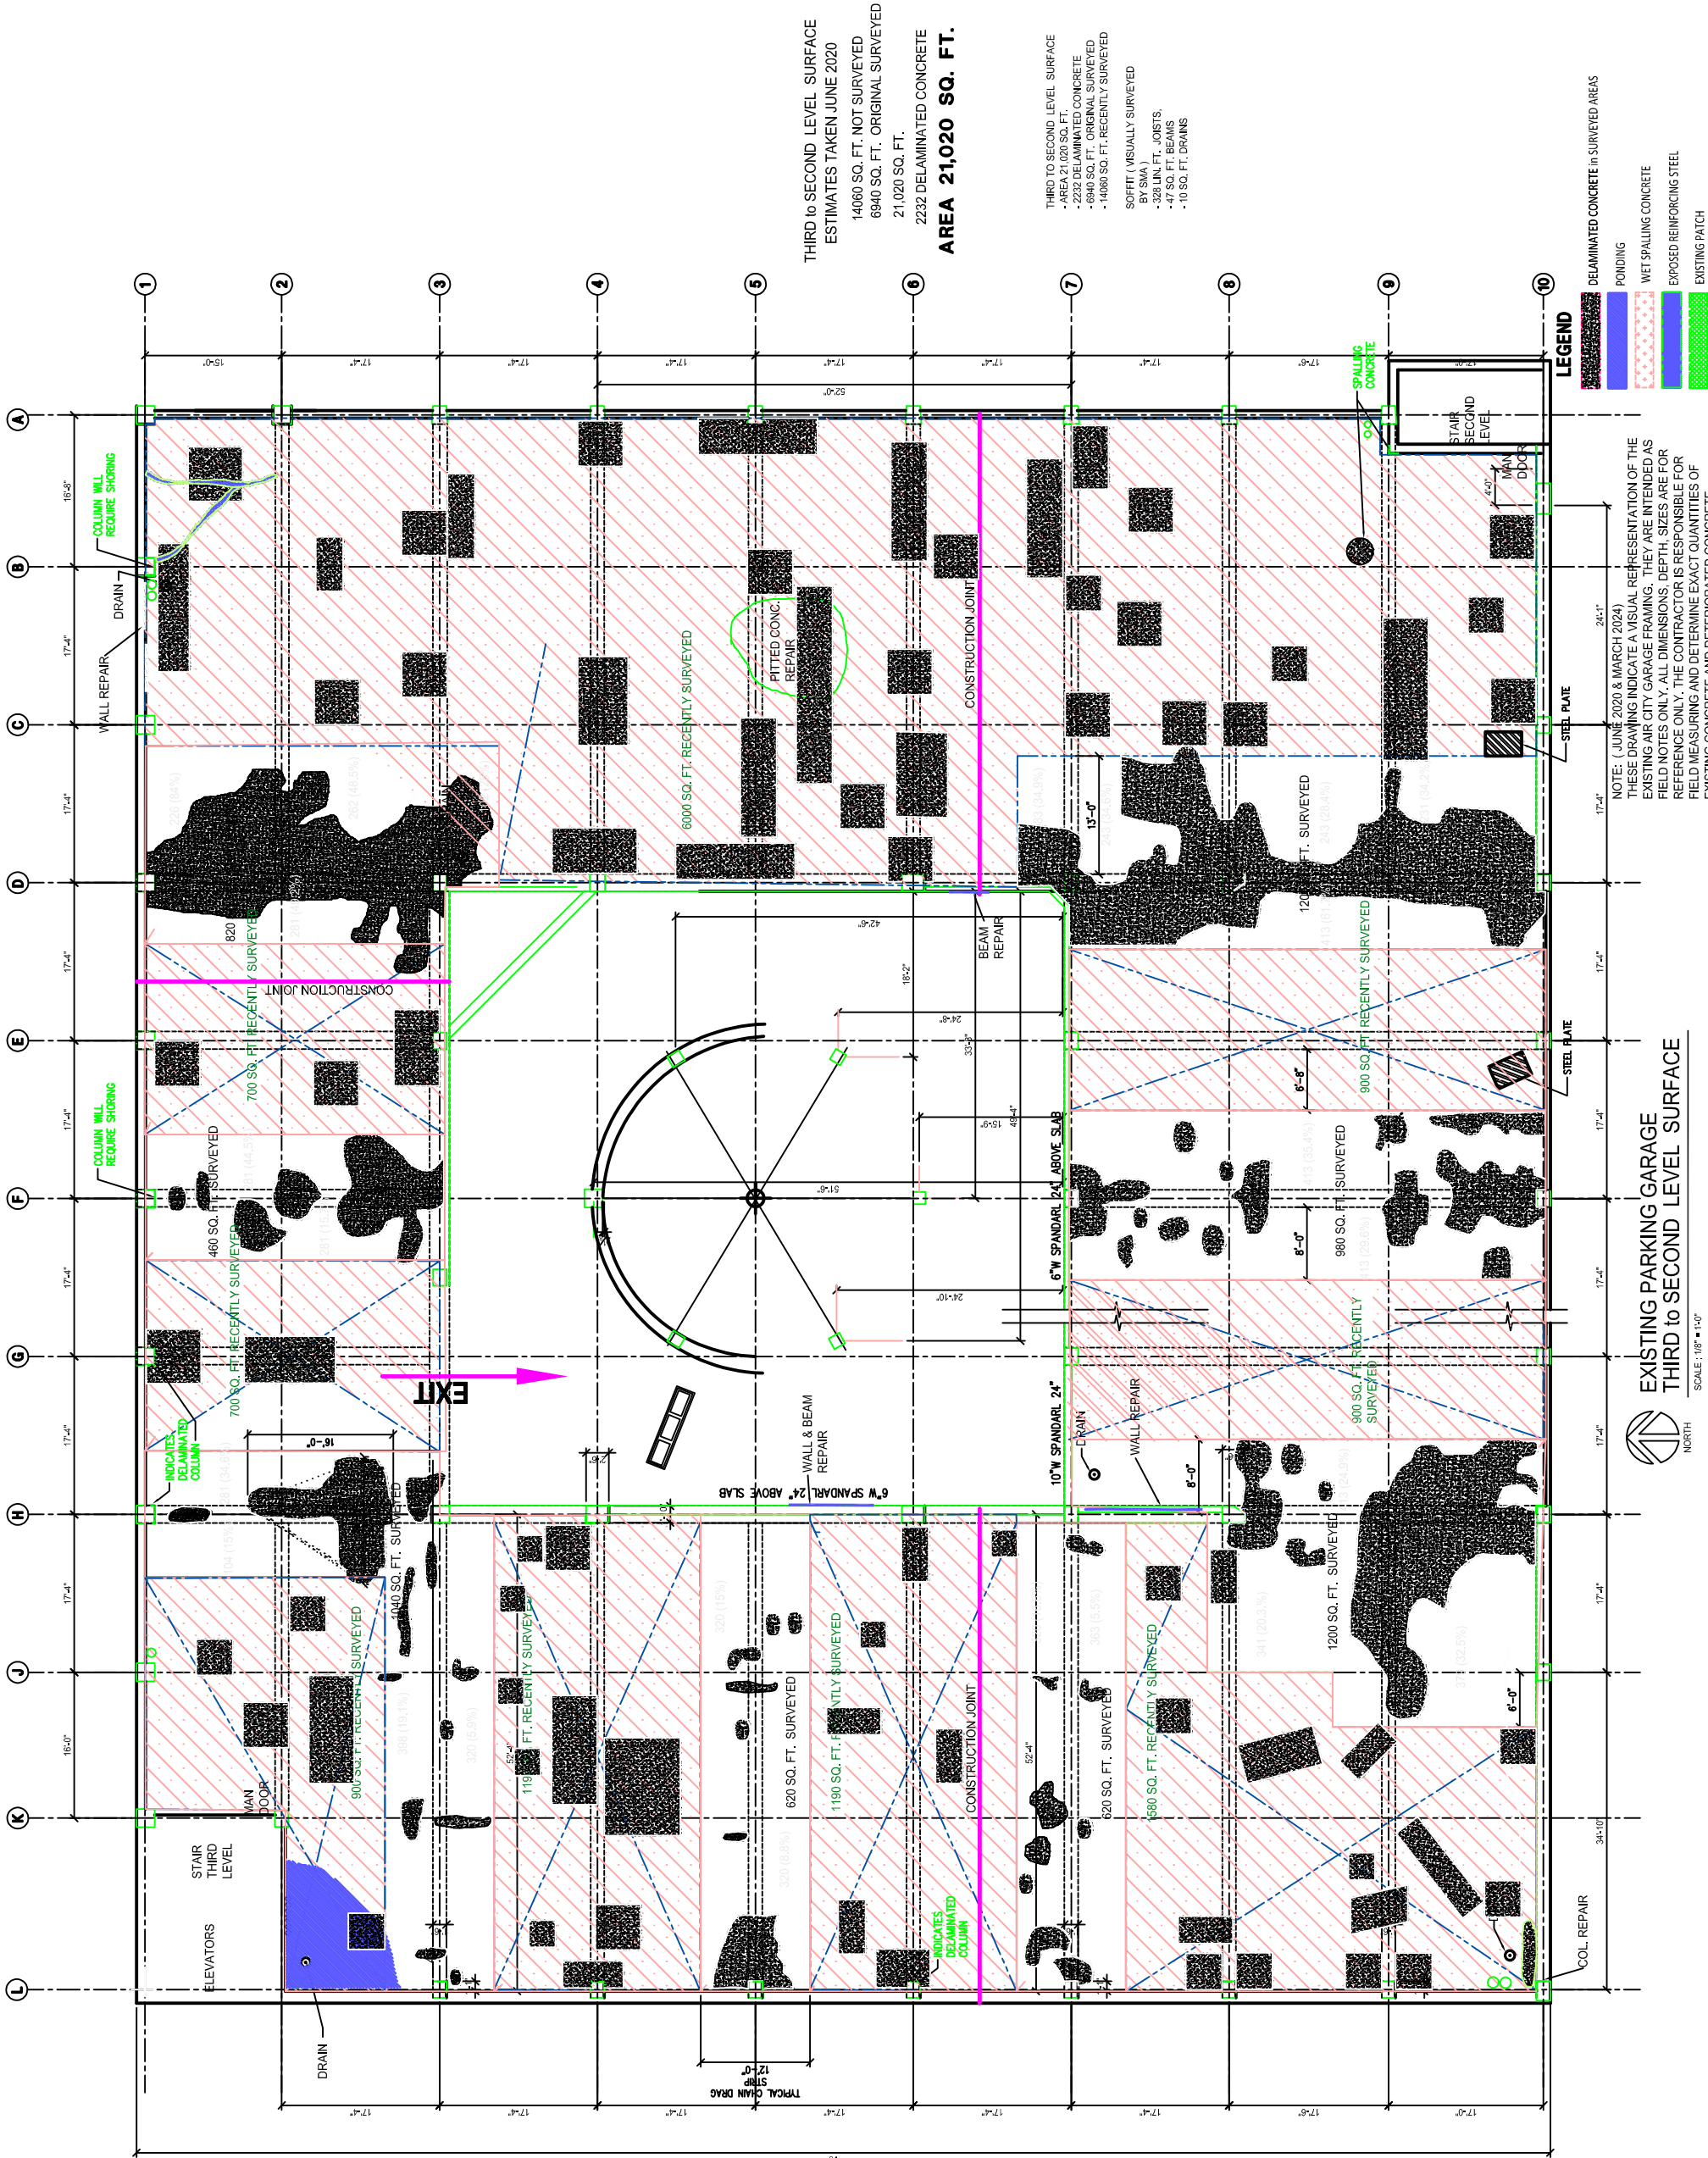
THIRD TO SECOND LEVEL SURFACE
ESTIMATES TAKEN JUNE 2020

14060 SQ. FT. NOT SURVEYED
6940 SQ. FT. ORIGINAL SURVEYED
21,020 SQ. FT.
2232 DELAMINATED CONCRETE

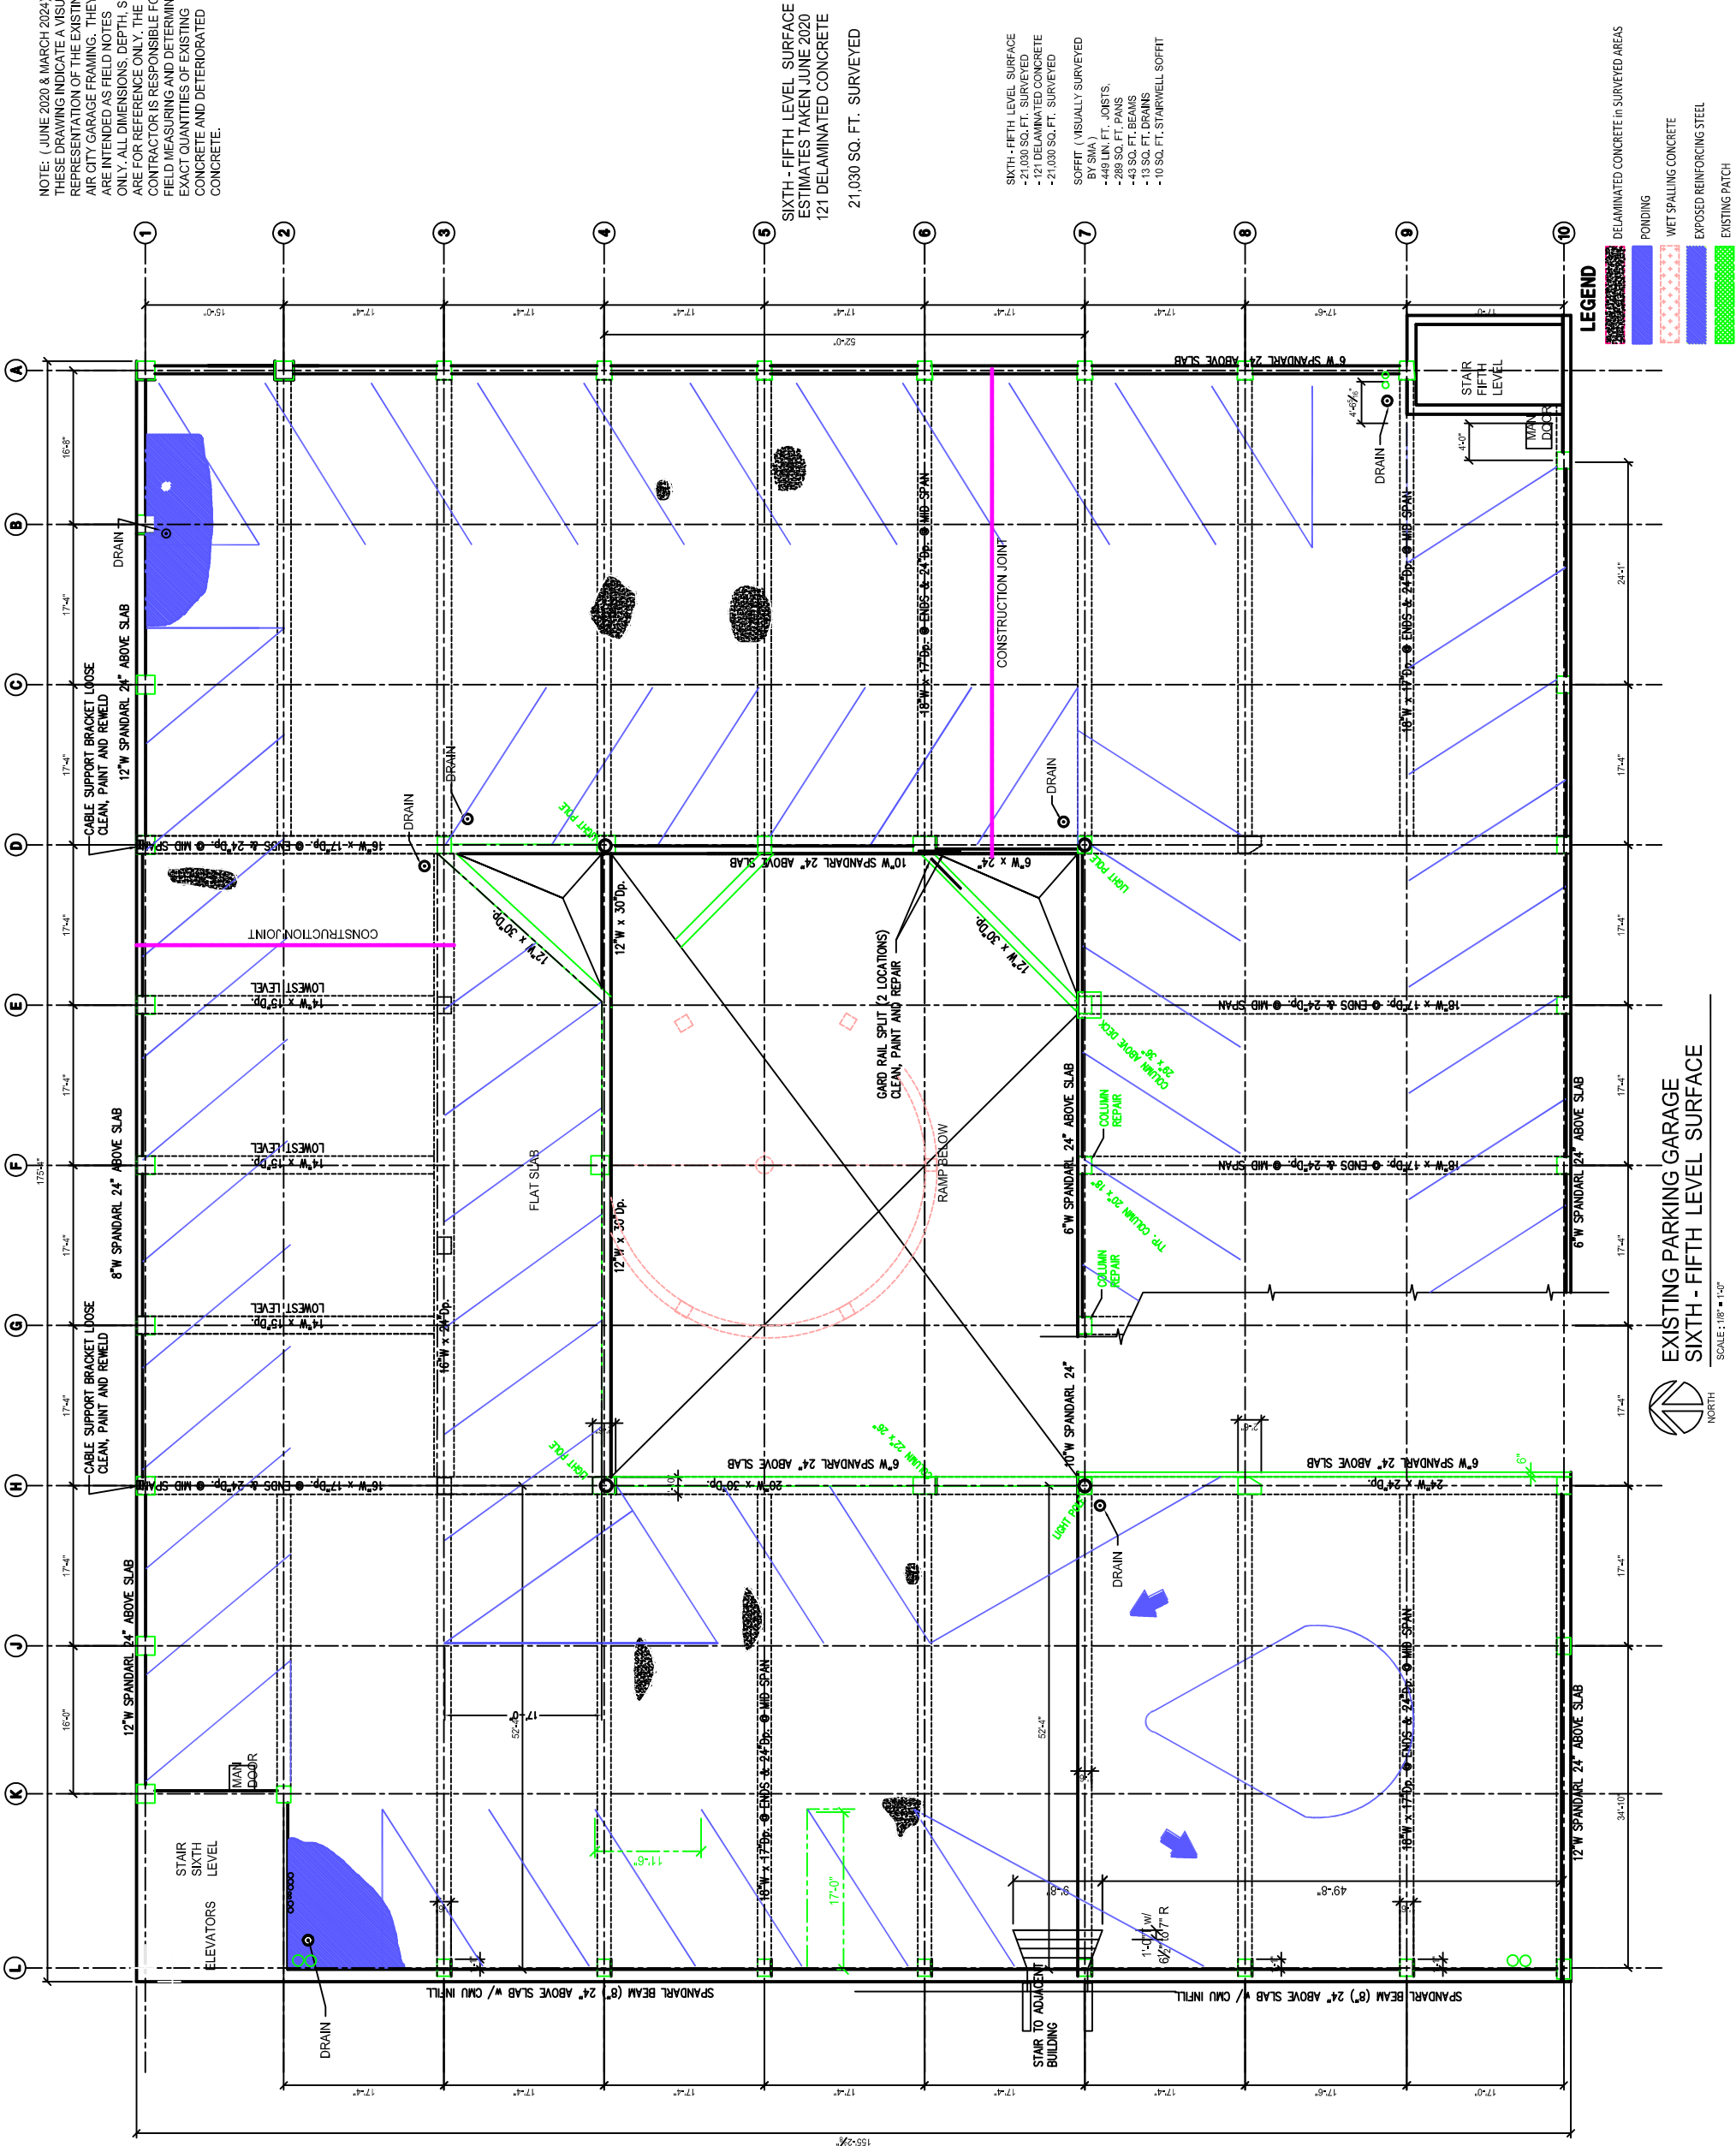
SIXTH - FIFTH LEVEL SURFACE
ESTIMATES TAKEN JUNE 2020
121 DELAMINATED CONCRETE
21,030 SQ. FT. SURVEYED

- SIXTH - FIFTH LEVEL SURFACE
- 21,030 SQ. FT. SURVEYED
 - 121 DELAMINATED CONCRETE
 - 21,030 SQ. FT. SURVEYED
- SOFFIT (VISUALLY SURVEYED
BY SNA)
- 48 LIN. FT. JOISTS,
 - 286 SQ. FT. FANS
 - 43 LIN. FT. BEAMS
 - 13 SQ. FT. DRAINS
 - 10 SQ. FT. STARWELL SOFFIT

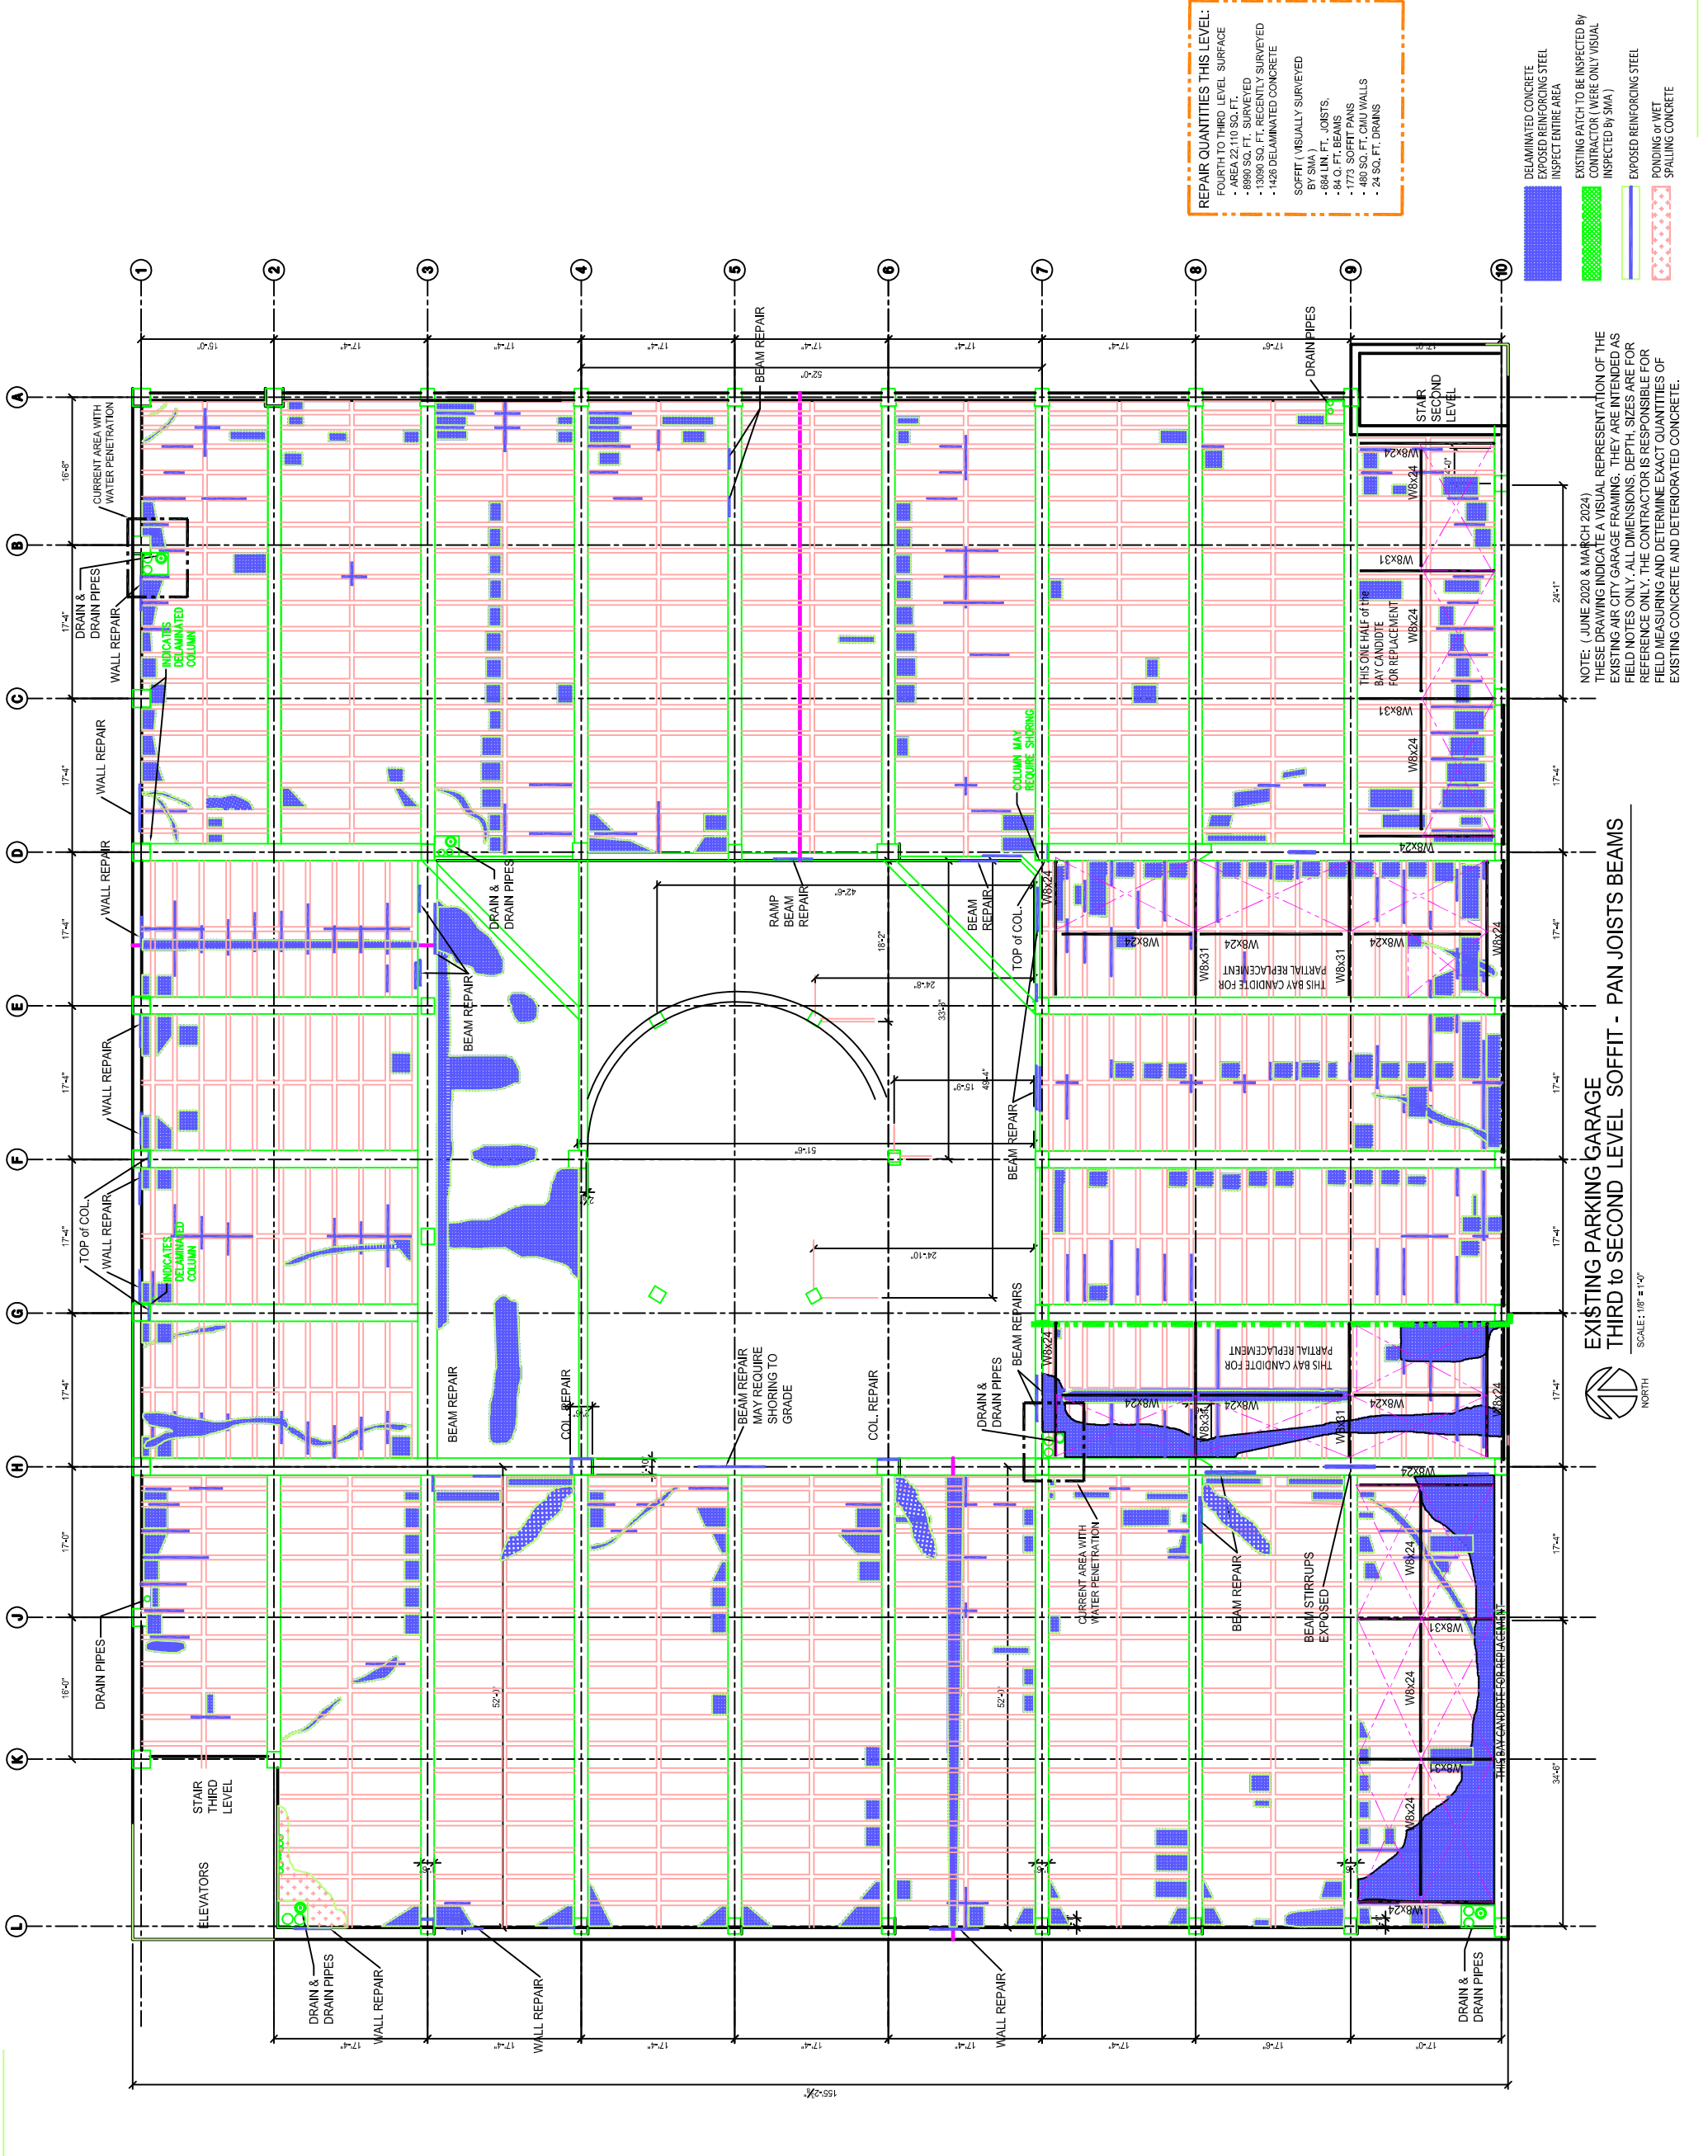
REPAIR QUANTITIES THIS LEVEL:
FOURTH TO THIRD LEVEL SURFACE
• AREA 22,110 SQ. FT.
• 8890 SQ. FT. SURVEYED
• 13090 SQ. FT. RECENTLY SURVEYED
• 1426 DELAMINATED CONCRETE

SOFFIT (VISUALLY SURVEYED BY SMA)
• 84 LIN. FT. JOISTS
• 84 Q. FT. BEAMS
• 1773 SOFFIT PANS
• 480 SQ. FT. CHU WALLS
• 24 SQ. FT. DRAINS

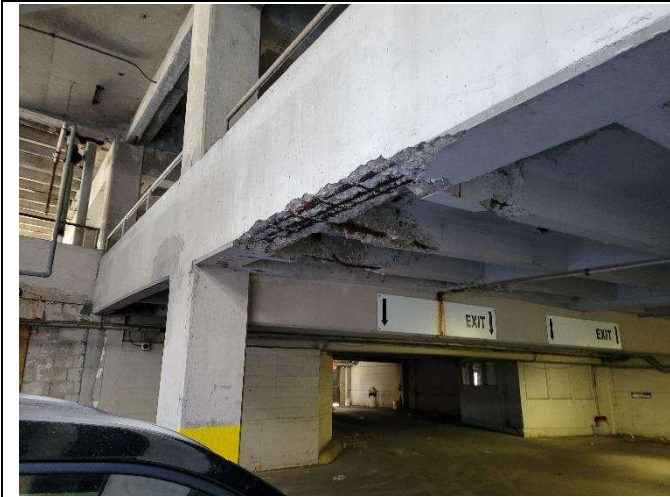
Photo 1 - Beam Joists 1st

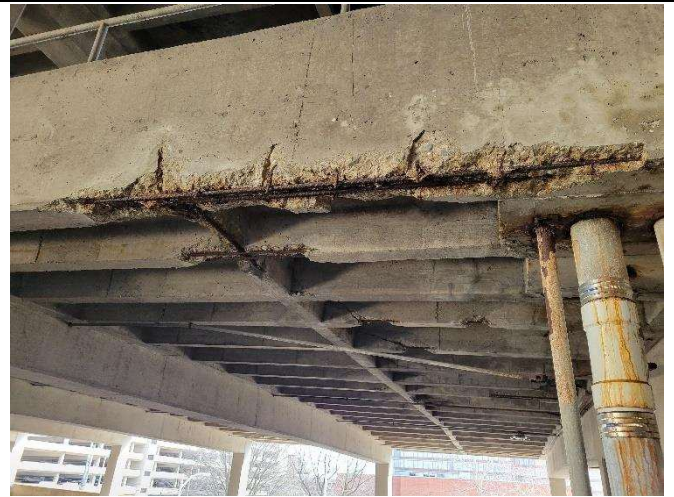
Photo 2 - Beam Joists Drain Pans

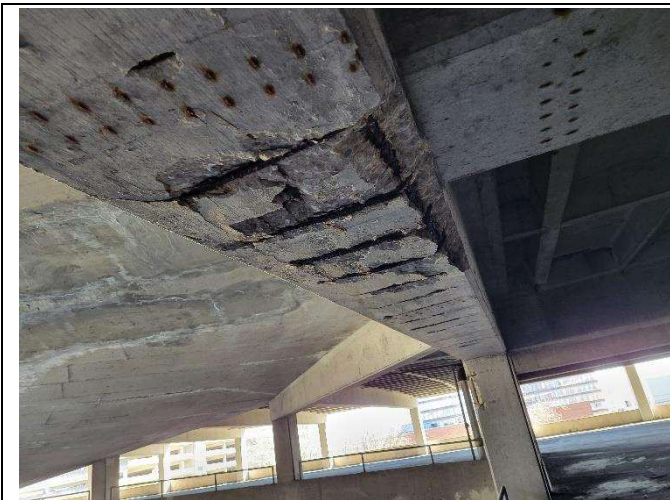
Photo 3 - Beam Ties Bot Bar

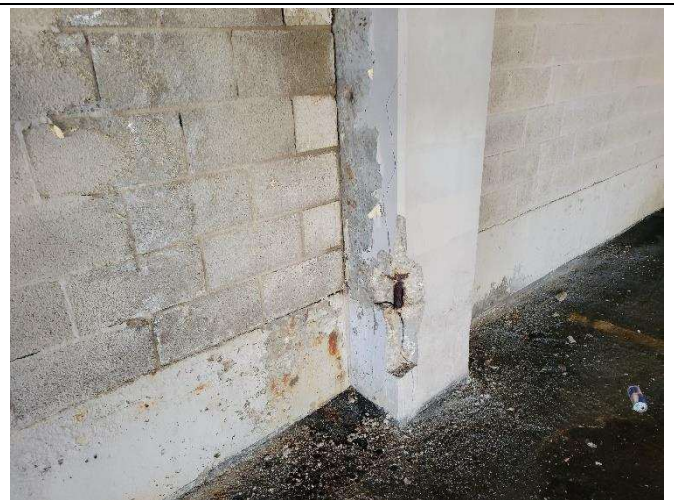
Photo 4 - CMU Wall Conc Wall Column

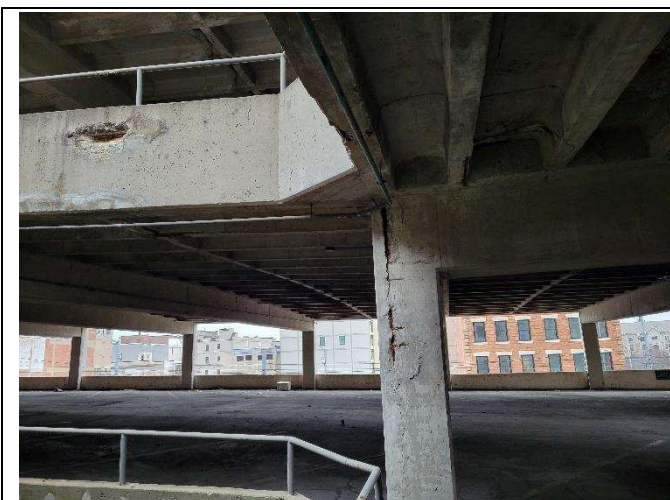
Photo 5 - Col Beams Joists

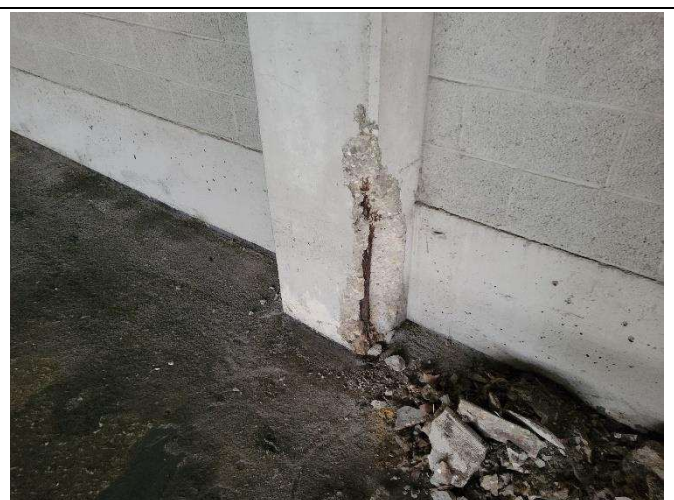
Photo 6 - Column to be Repaired

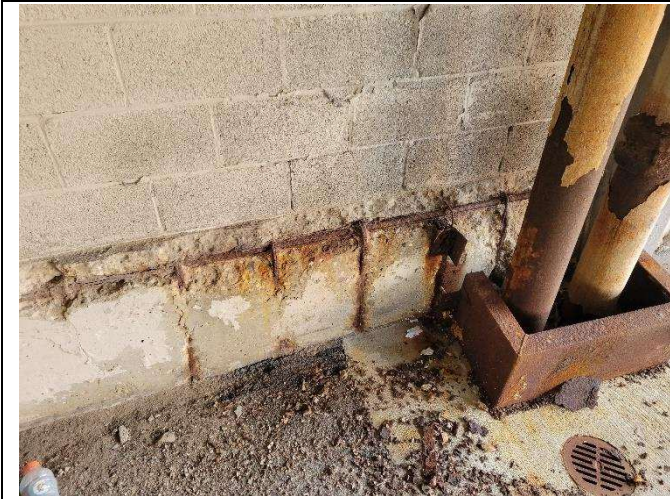
Photo 7 – Conc Blk Wall at Drain

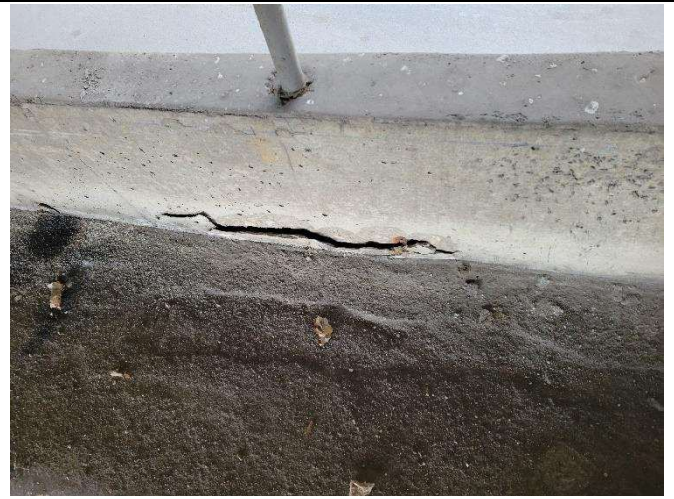
Photo 8 – Divider Wall Repair

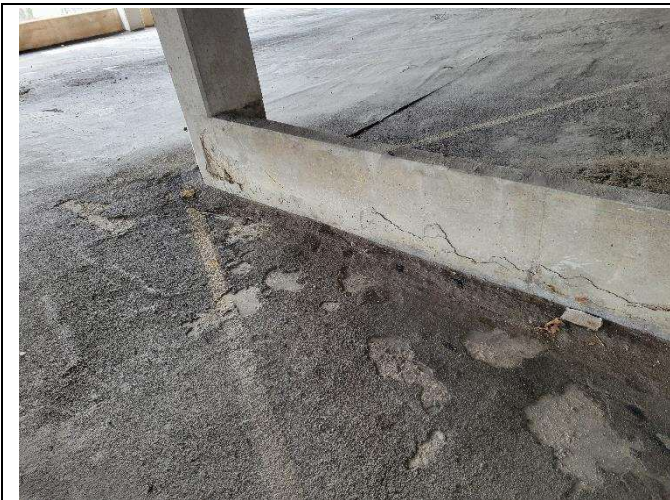
Photo 9 – Divider Wall Topping Repair

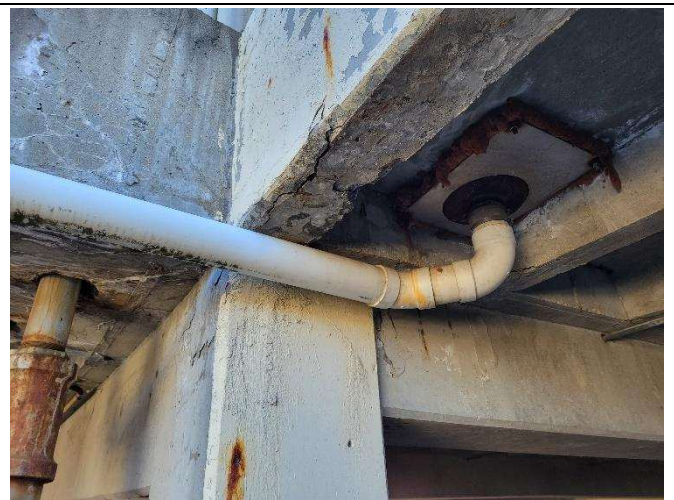
Although review of mechanical, electrical and plumbing (MEP) systems was not part of our scope of work we did observe that many elements of the cast metal drainage lines have badly corroded and need to be replaced. Where the concrete drainage box below the slab is deteriorated from

Photo 10 – Drains

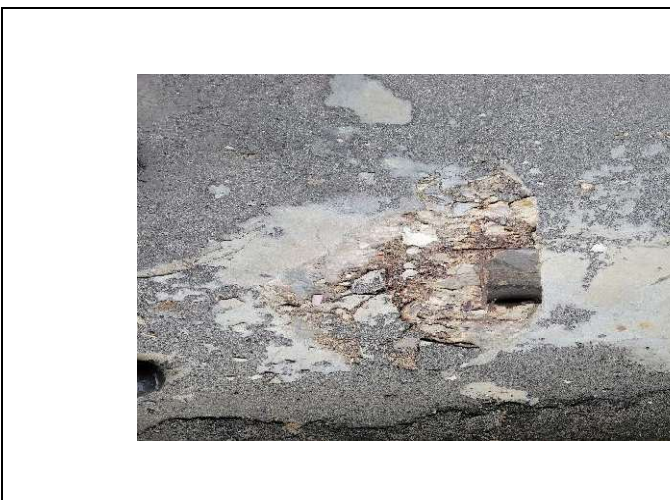
Photo 11 – Holes to be Repaired

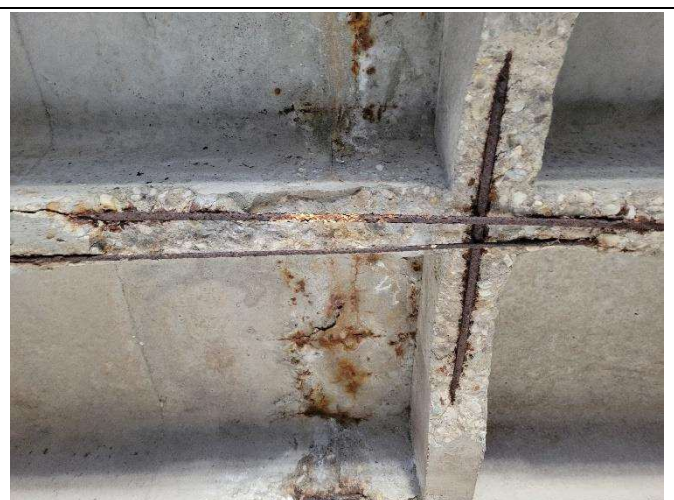
Photo 12 – Joist and Bridging
