AIR CITY GARAGE
27 S. JEFFERSON STREET
DAYTON, OH 45402

PREPARED BY :
STRUCTURAL ENGINEER

SMA JOB NUMBER : 24.200.020 (ORIGINAL 19.200.154)

AIR CITY GARAGE
UPDATED STRUCTURAL CONDITION STUDY
Dayton, Ohio
March 27, 2024

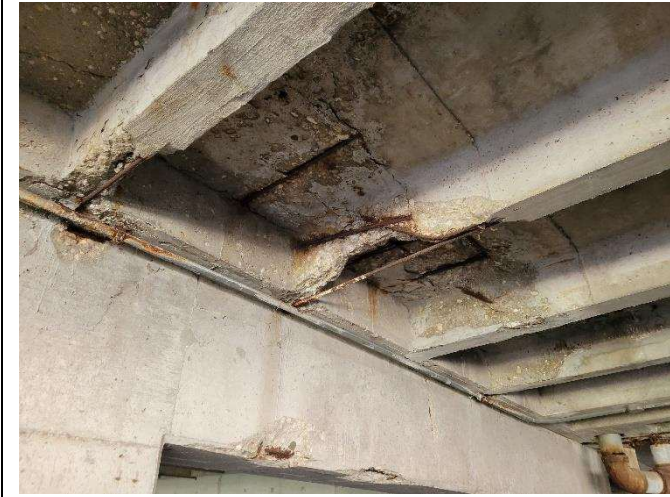
Photo 13 – Joist Pan Beam Repairs

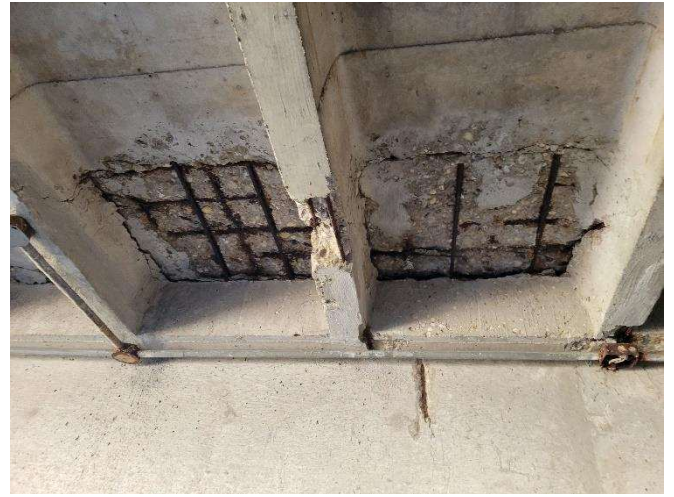
Photo 14 – Joist Pan Wall Repairs

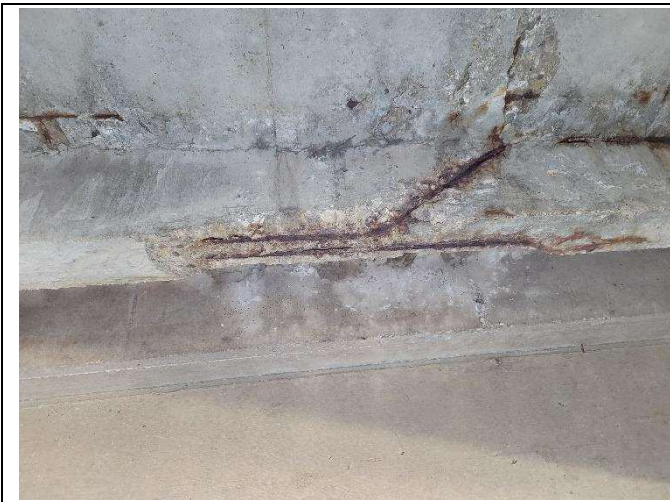
Photo 15 – Joist w Truss Bar

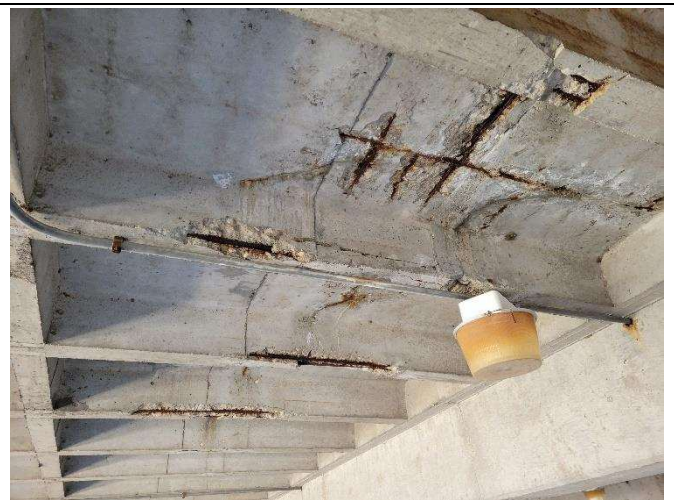
Photo 16 – Joists and Pans

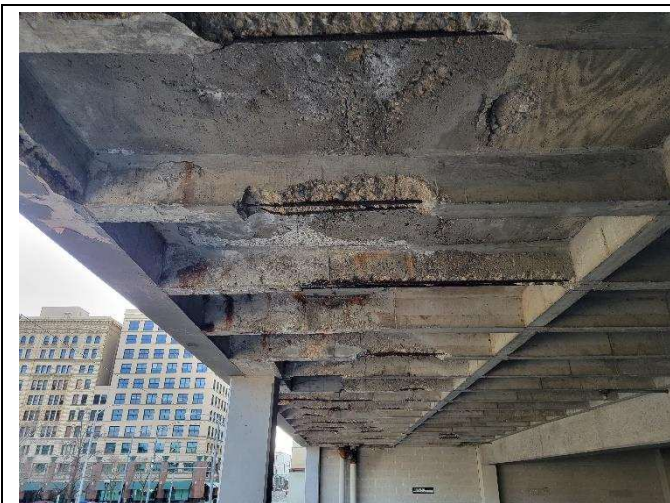
Photo 17 – Joists Pans Replace

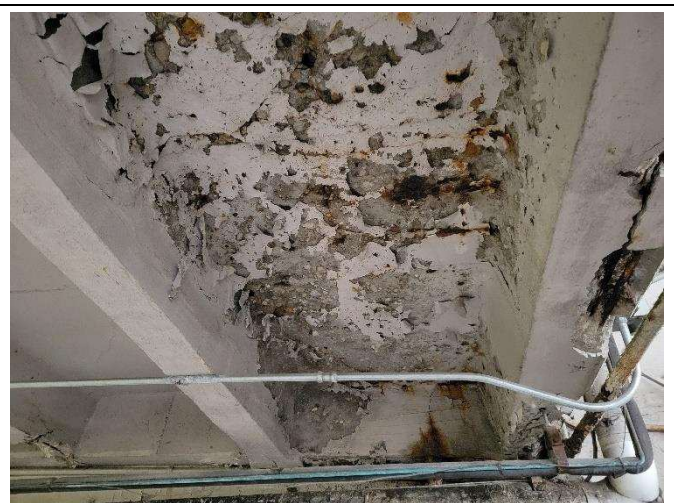
Photo 18 – Pan Deteriorated

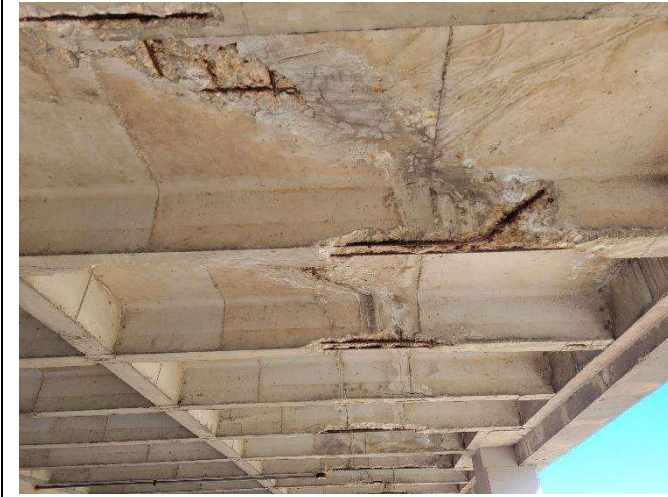
Photo 19 – Pan Joists

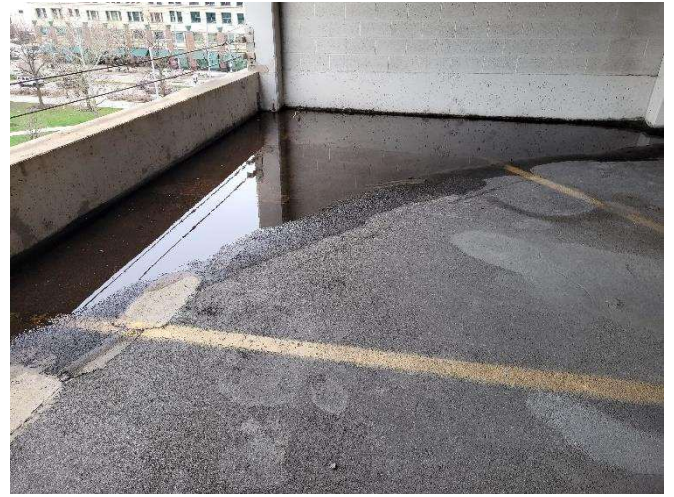
Photo 20 – Pond

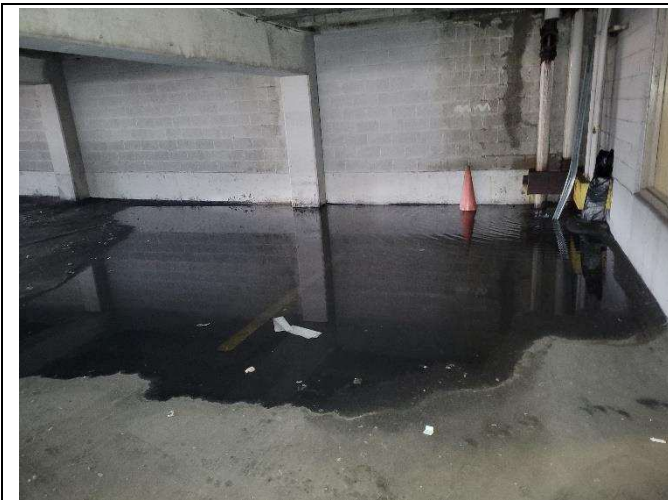
Photo 21 – Ponding at Elevators Wall Damage

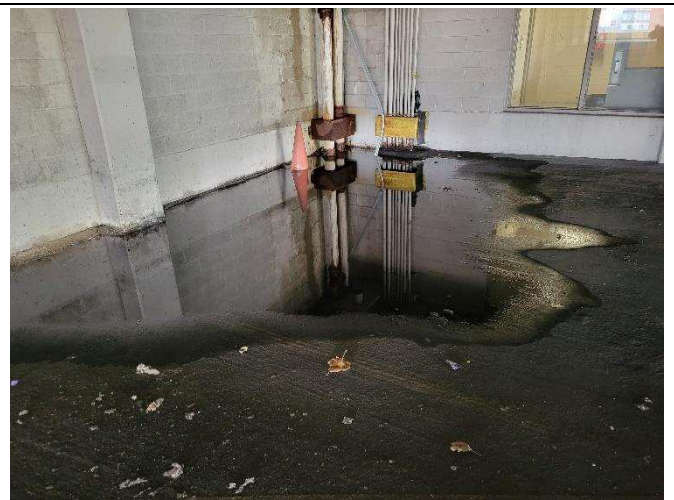
Photo 22 – Ponding Wall Damage

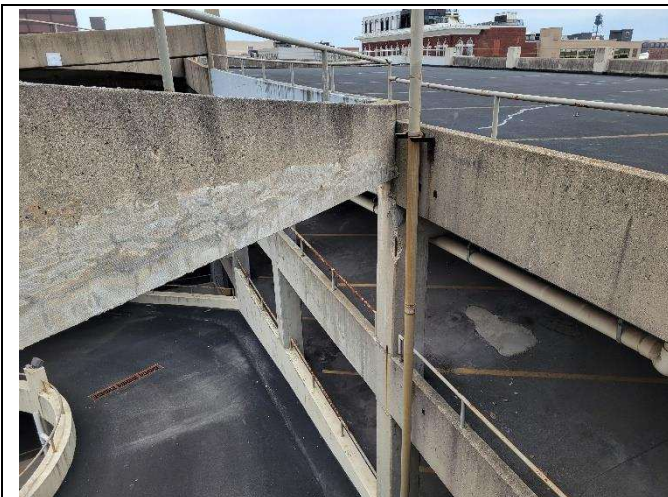
Photo 23 – Previous Repairs Beam Column

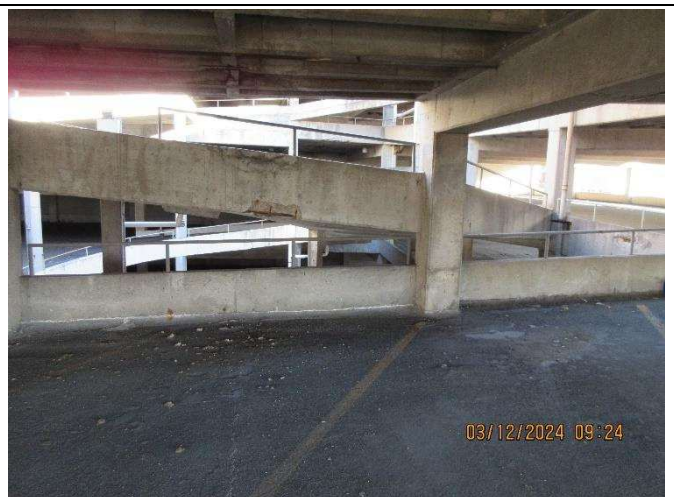
Photo 24 – Ramp Beam Repair

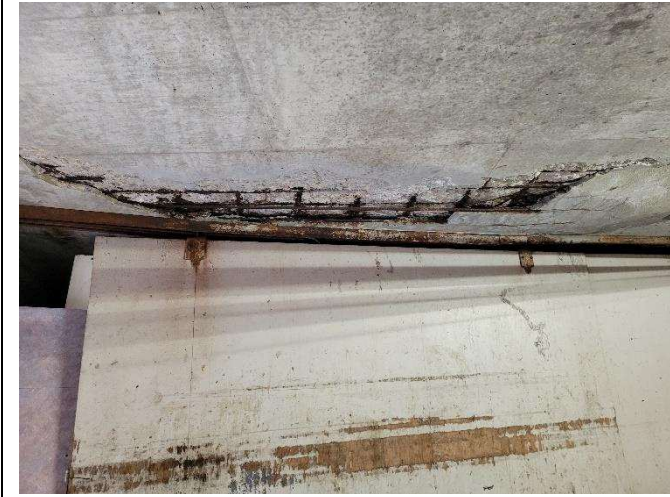
Photo 25 – Ramp Lowest Level

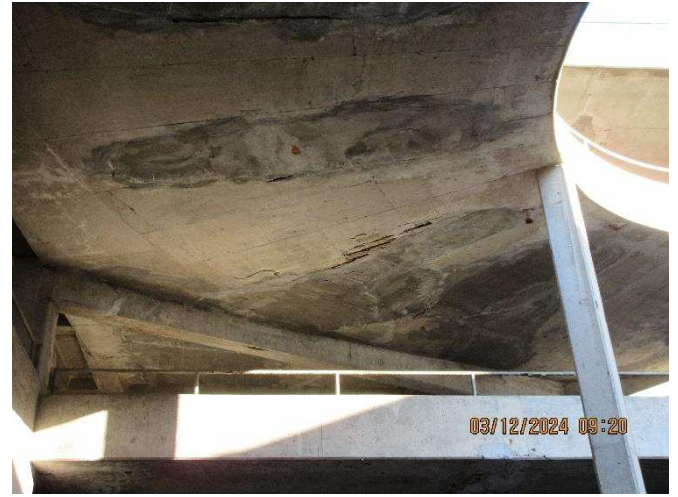
Photo 26 – Ramp Previous Repairs to be Inspected

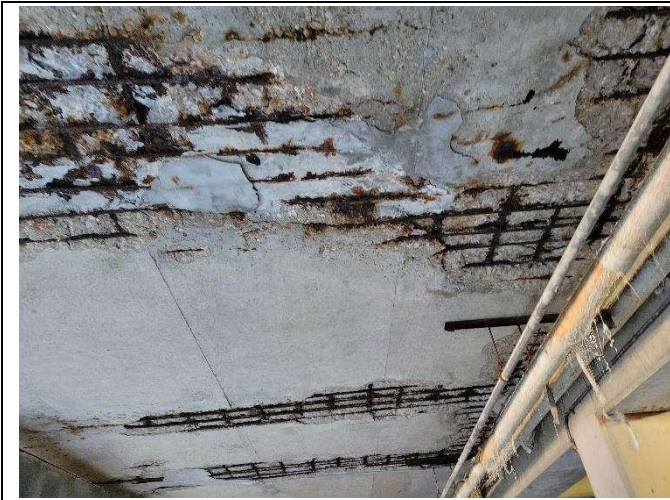
Photo 27 – Replace Flat Slab Section

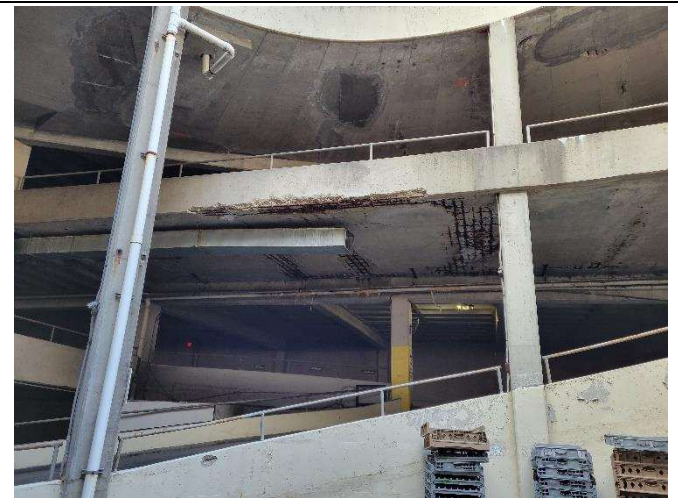
Photo 28 – Replace Flat Slab Spandrel Beam

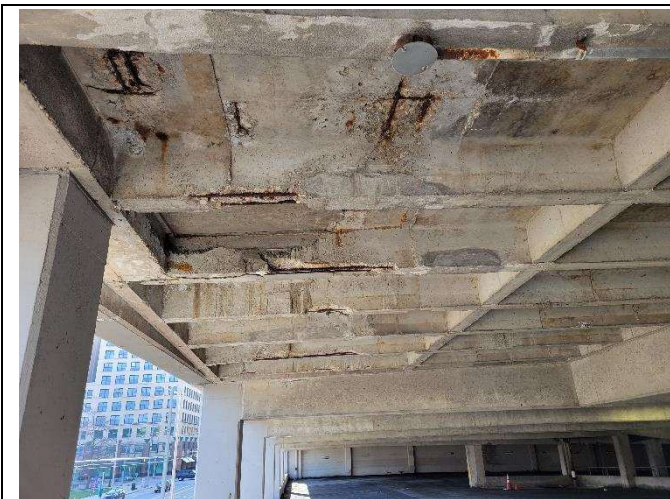
Photo 29 – Replace Section of Bay

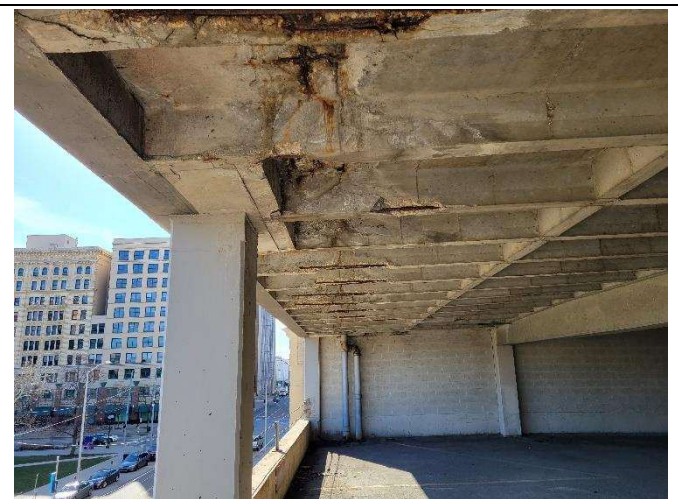
Photo 30 – Replacement Candidate

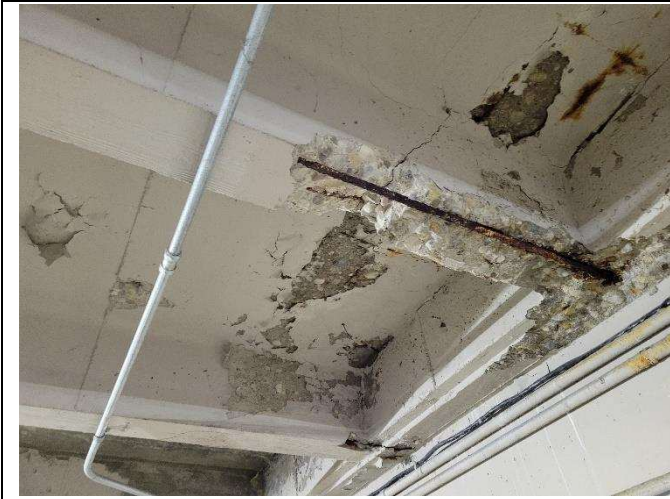
Photo 31 – Shear Crack Add Steel Repair

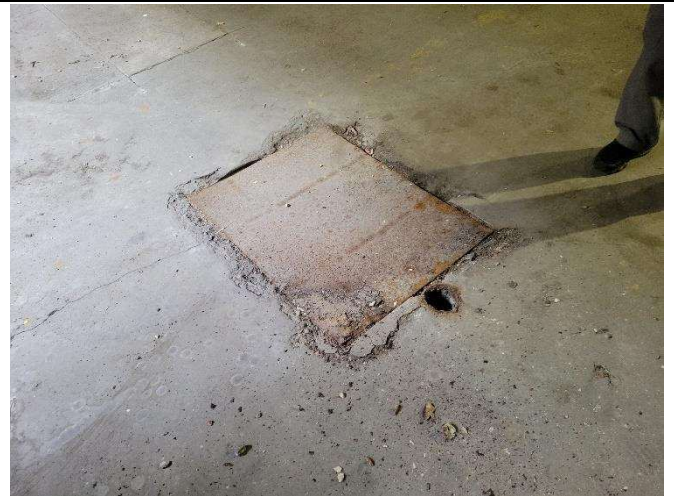
Photo 32 – Slab on Grade Opening Wood Cover

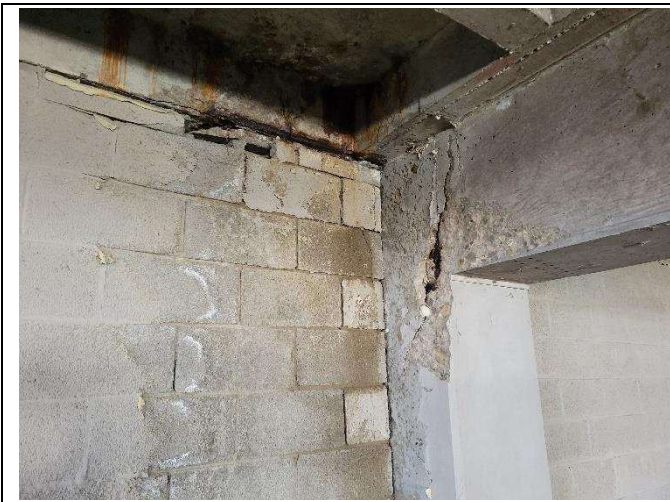
Photo 33 – Wall Beams Column

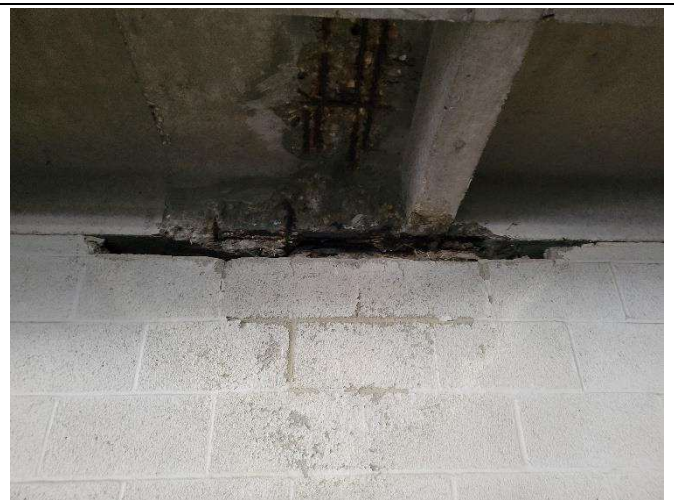
Photo 34 – Wall Spandrel Joist Pan
