Pre-Renovation Building Inspection for Asbestos-Containing Materials

**Fourth and Walnut Centre
105 E. 4th Street
Cincinnati, Ohio**

August 2, 2018

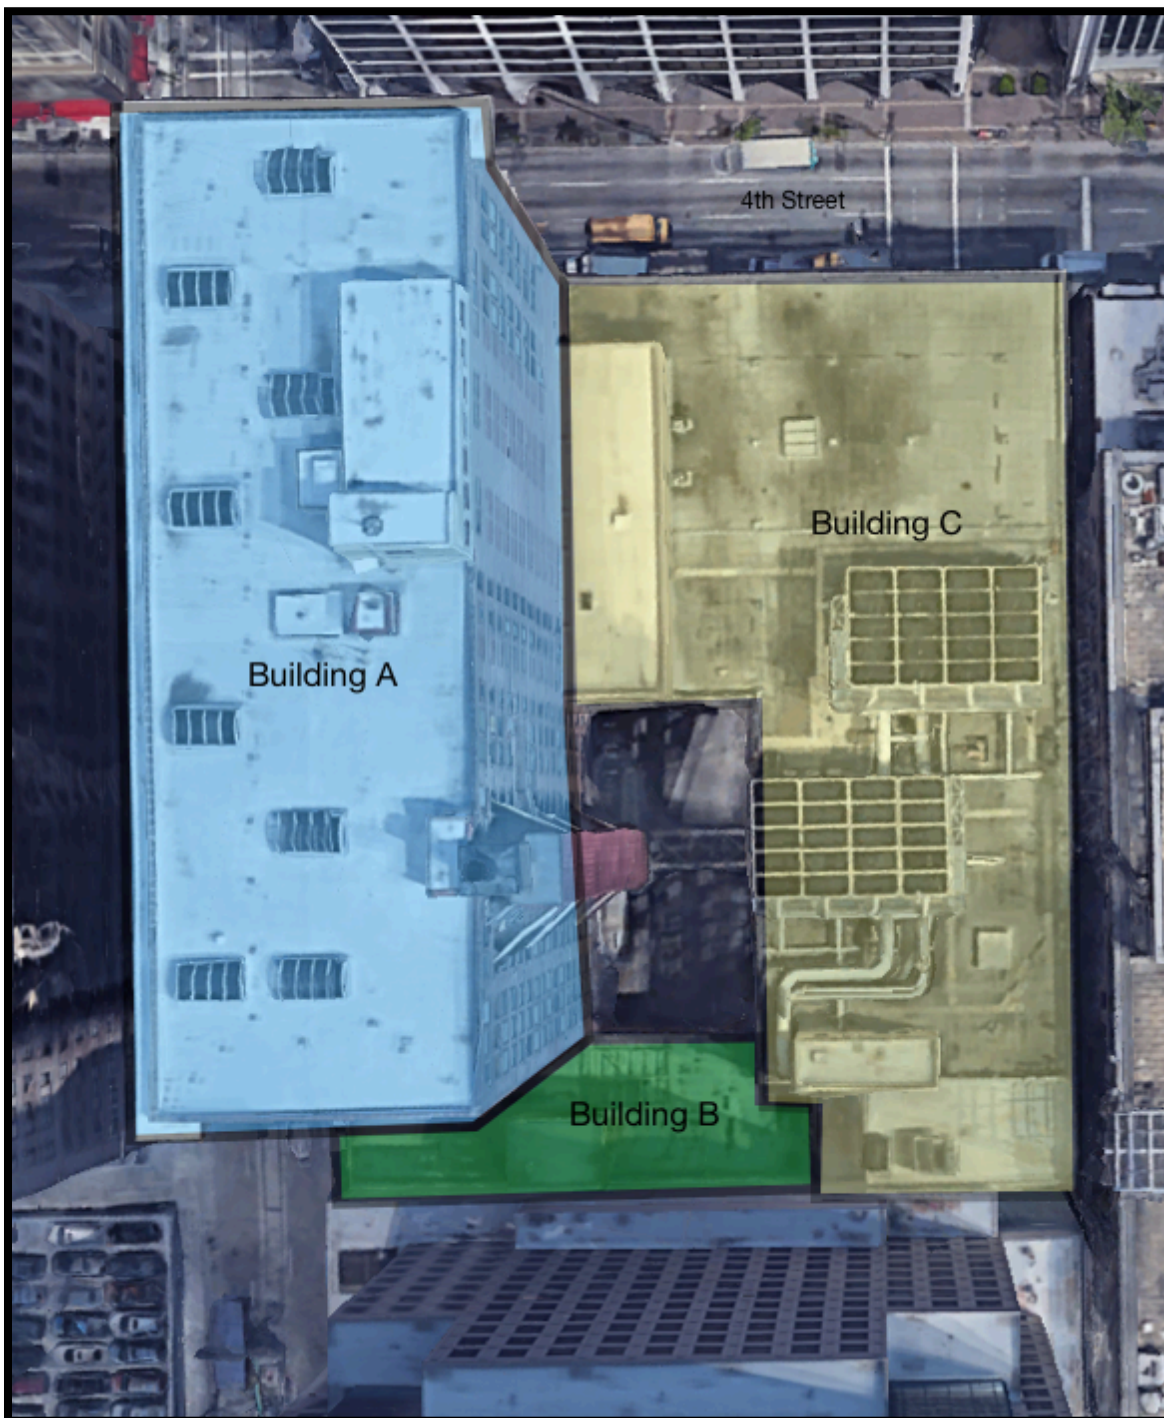
The property (105 East 4th Street) is subdivided into three contiguous buildings identified as Buildings A, B, and C, each having different years of construction.
